PROJECT PROFILE

Project Type: Culvert/outlet protection

Product Type: North American Green RevetMax® ShoreMax
Flexible revetment mat over VMax SC250 & P550
Turf Reinforcement Mat (TRM)

Project Location: Bastrop, Texas

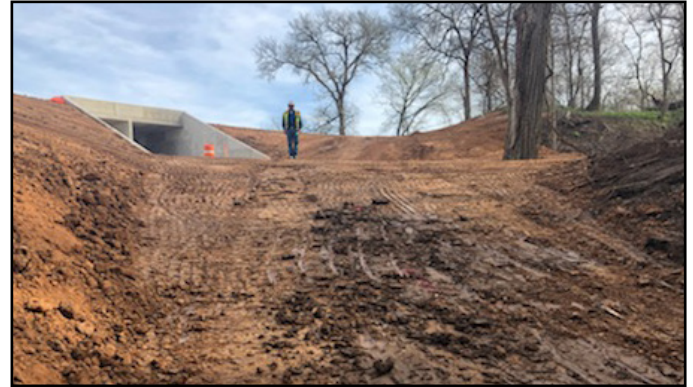
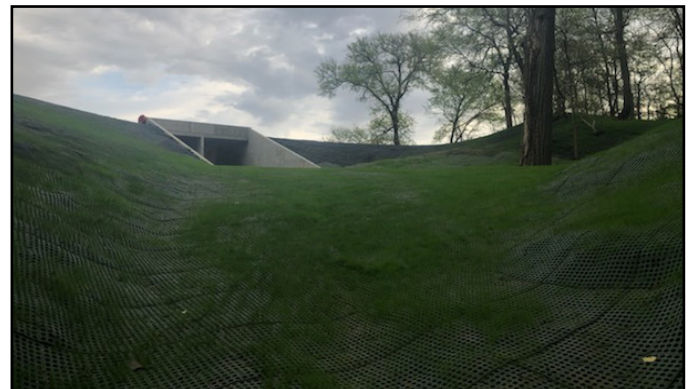
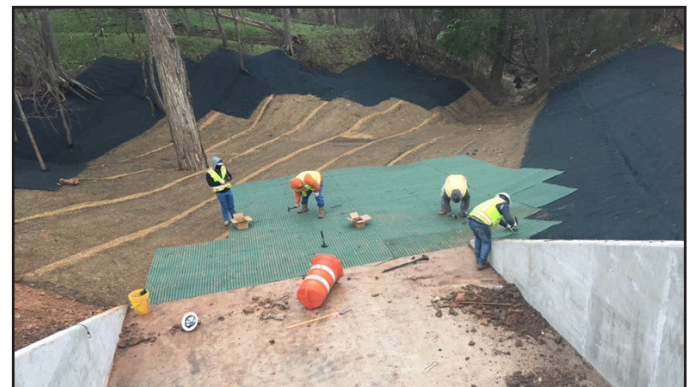
Before and after images of a wide channel managing storm discharge from the 6 ft culvert. The steep, meandering channel was stabilized with ShoreMax transition mat installed over permanent TRMs (bottom).

The design of the project consisted of the SC250, a straw/coconut fiber matrix permanent TRM, to be placed along the channel bottom, starting from the concrete culvert and extending to the edge of the property. The UV-stabilized ShoreMax rubber transition mat was placed atop of the TRM and secured with 12" long 3/8 J-shaped rebar staples. P550 a poly-fiber filled TRM was installed along the side slopes and secured. The area was pre-seeded with a turfgrass seed blend, selected for the site specific conditions. Within weeks the vegetation began to establish through the permanent erosion control system. As the vegetation established over the course of a few months, the total performance of the system increased to provide similar protection to comparable hard armored systems such as rock.
