Project Showcase

Erosion-control mix rebuilds Clyde’s creekbank

| A North Carolina town used a portfolio of geosynthetic erosion-control and reinforcement materials to restore a local streambank and relieve safety threats.

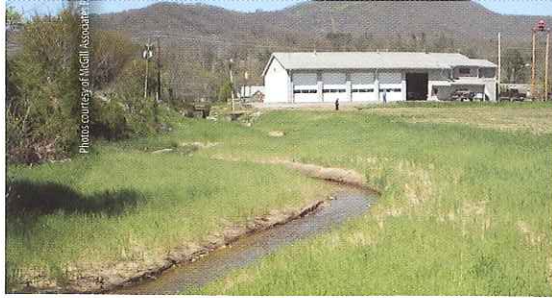
Photo 1 | This “after” photo shows the restored tributary winding through the small town of Clyde, N.C.

Located upstream of the Pigeon River, the narrow tributary (see “before” **Photos 2, 3** and “after” **Photo 1**) flows behind the town’s fire station, a local bank, and a Methodist church. Historic farming practices had straightened more than 500ft of the east and west banks of this creek, with streambank slopes steeper than 1:1 and vertical bank heights of 11ft (**Photo 2**).

The restoration project, with a blend of native grasses and spot-on biodegradable erosion-control materials working on its behalf, was regularly watered by seasonal spring rainfall and began to germinate within two weeks. A month later, a healthy stand was apparent, and two months later, 18–24in. grasses covered the Clyde streambank (**Photos 1 & 8**).

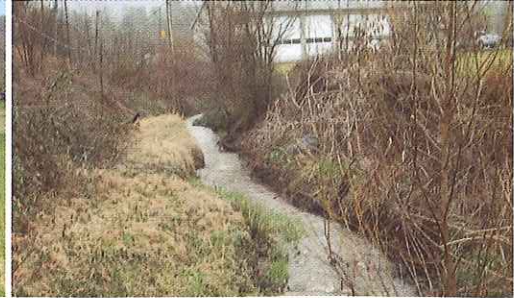
Photo 2 | This “before” photo shows the artificially straightened tributary with steep banks.

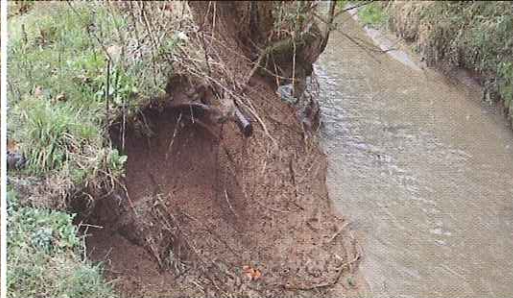
Photo 3 | Post-hurricane runoff accelerated creekbank erosion.

Destruction from the hurricanes allowed excessive amounts of runoff to rush through this channel at a high velocity, causing accelerated streambank erosion (**Photo 3**). If further disturbed during other high-flow storm events, the exposed soil and steep vertical slopes could further erode, threatening the stability of its bordering buildings and pushing even more sediment into the French Broad River Basin.

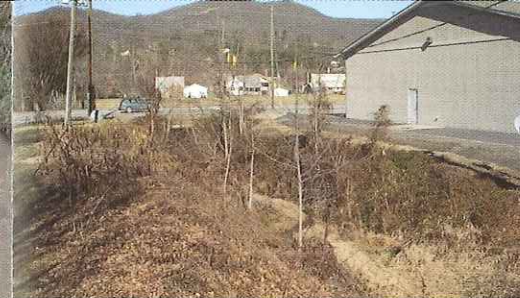
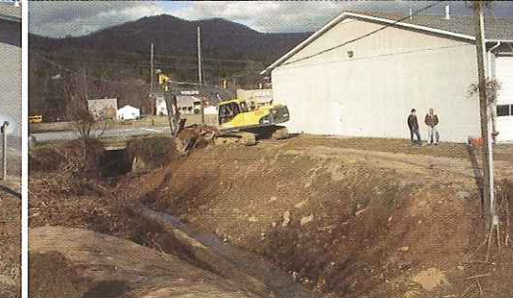
Photos 4 & 5 | The addition of an MSE retaining wall added strength to an unstable slope.

The proposed restoration plan called for constructing a meandering stream channel at the existing bed elevation and establishing a new flood plain. The addition of a mechanically stabilized earth (MSE) retaining wall would add strength to unstable slopes and native vegetation would create habitat, slow water flow, and beautify the site (see **Photos 4–8**).

In January 2009, Johns and his team completed the planned restoration of the site, including the relocation of the stream channel, decreasing the stream bank slopes and creating a stable, green retaining wall (see **Photos 4–8**).

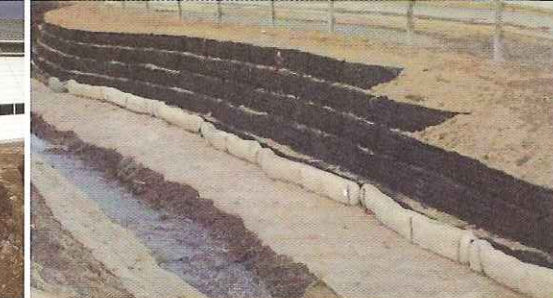
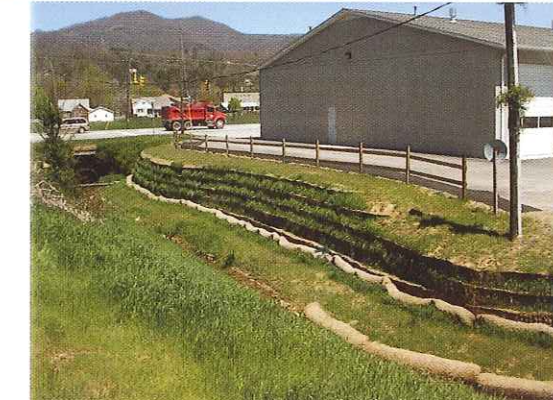
Photos 6 & 7 | A geosynthetically-reinforced MSE slope stabilized the creekbank adjacent to the Clyde Fire Station.

For quick vegetation establishment, Johns selected a hydraulic erosion-control product that is made with mechanically processed straw fibers, reclaimed cotton plant material, and performance-enhancing tackifiers that form a protective layer that holds soil in place. Mixed with a range of seven different native grass seed varieties, as dictated by the North Carolina Department of Environment and Natural Resources, Division of Water Quality, it was applied at a rate of 2,000 to 2,500 pounds per acre to the streambanks and the MSE retaining wall—a “living wall” constructed near the fire station (**Photos 6 & 7**) to stabilize the

bank and designed to eventually blend into the surrounding landscape.

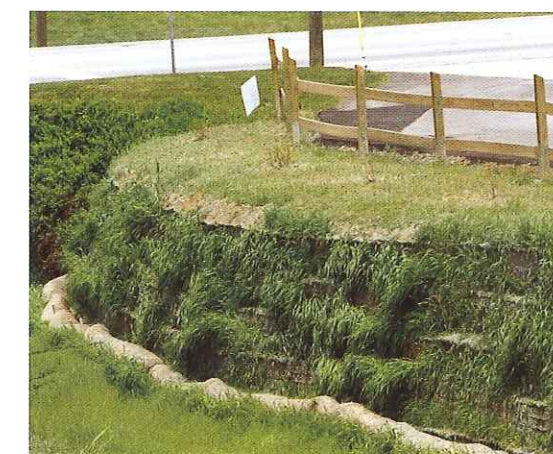
Photo 8 | The stabilized creekbank was designed to eventually blend into the surrounding landscape.

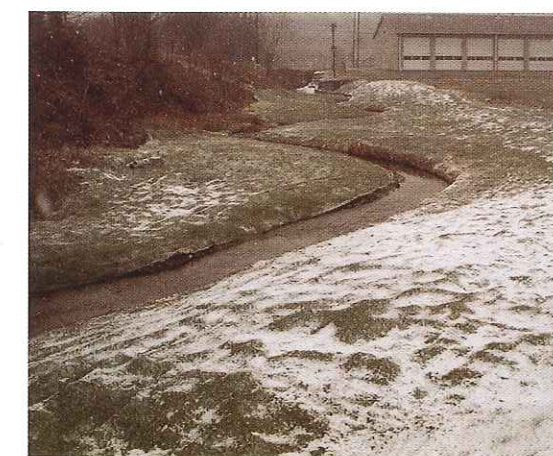
Photo 9 | Even after a February snowfall, “there were no adverse effects, no loss of product, and the vegetation continued to grow healthy and strong.”

“In February, not even a week after it had been sprayed, we experienced significant snowfall,” said Johns (**Photo 9**). “We wondered what effect the freezing temperatures and snowmelt would have on the newly applied product, but there were no adverse effects, no loss of product, and the vegetation continued to grow healthy and strong.”
