FACTS

VOLUME 4
NUMBER 4

NORTH AMERICAN GREEN QUANTIFIES EROSION CONTROL AND TURF REINFORCEMENT PROPERTIES OF THE P300P CHANNEL LININGS AND C350 PROTOTYPE

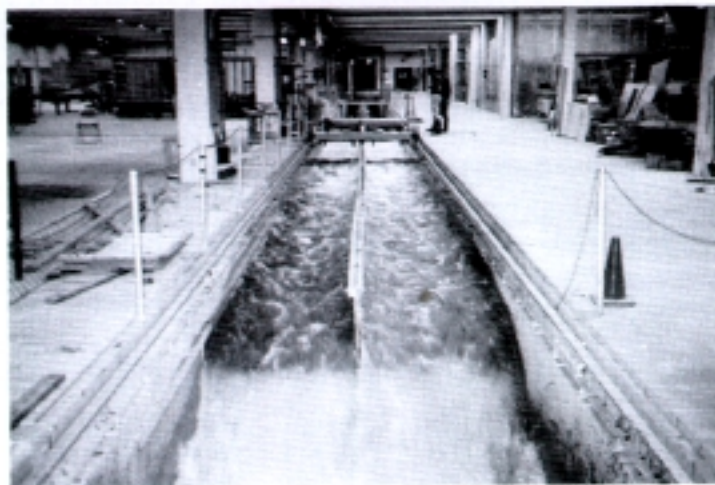
The tests were conducted by forming two side-by-side channels (two replications for each material) in a 50 foot test flume using a sandy loam soil (with prepared seed bed), and then installing the erosion control materials on top (matting, sod, reinforced sod). Water was forced down these channels from a 3 feet diameter pipe backed by 35 feet of head pressure. This set-up allowed us to discharge from 10 to 75 cubic feet of water per second at average velocities over 20 feet per second down the test channels. Each test consisted of a series of .5 hour flow events, with a final run extending several hours. After each flow event, soil loss measurements were taken to determine product performance.

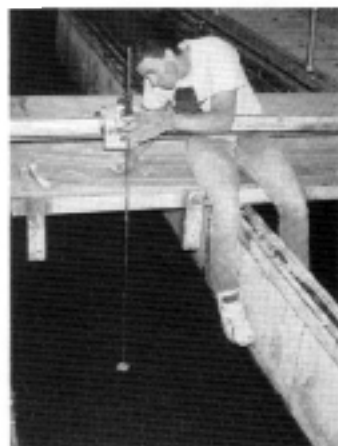
Under the short duration, super-high velocity tests, differences in the P300P and C350 mattings materialized. The C350 showed signs of damage at average velocities over 13 feet per second. The P300P, on the other hand, resisted structural degradation up to over 20 feet per second.

Although North American Green would not recommend the use of either matting at velocities higher than those found to cause excessive soil loss, the super-high velocity test gives us a reference point for material survivability — an answer to the question "if design velocities were ever exceeded, could the matting be reused after repairing the channel?"

After a soil loss failure was reached on each material, two final tests were performed to determine material durability under both a super high velocity and an extended flow period. Both the P300P and C350 survived a 10 feet per second flow period of 16.5 hours without significant damage. Though a soil loss failure had been reached in the previous run, the linings did continue to provide protection for the channel surface throughout the extended flow period.
